BOA Architecture / Government Services
Rancho Palos Verdes ADA Assessment

Facility Report with Photos - Programs Services

Facility ID: # 02B - City Hall Buildings

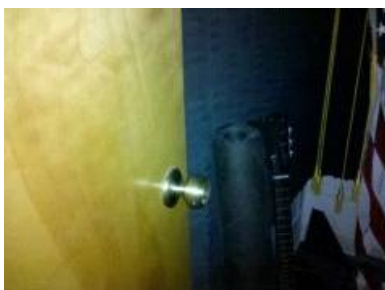
Keynote 29

11.11 - Single-Action Hardware - Handles, locks, and latches or other operative devices are not operable with one hand and without tight grasping, pinching, or twisting of the wrist. (U-shaped handles, levers, and push/pull type mechanisms are acceptable designs.)

Existing Condition: Door knob.

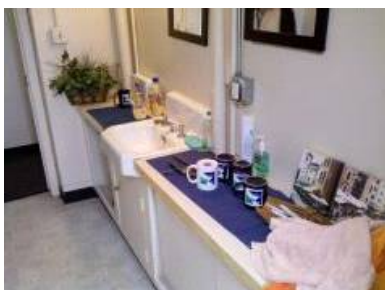
Keynote 55

16.70 - Lavatories - Lavatory does not comply with ADAAG and CBC requirements. (ADA Standards require at least one lavatory to be accessible. CBC Standards prior to August 1, 2009 required all lavatories to be accessible. Effective August 1, 2009, amended CBC Standards require at least 5% of lavatories, but not less than one lavatory, to be accessible.)

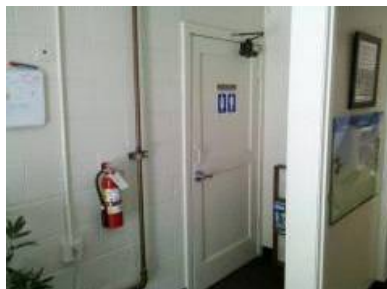
Keynote 65

16.13C - Unisex RR Geometric Symbol Signage - Circle/Triangle - Doorway leading to a unisex toilet room is not identified by a 12" circle, 1/4" with a 1/4" thick triangle superimposed and within the circle. OR Circle and triangle are provided, however they are accompanied by words in raised characters and Braille. (ADA and CBC Standards require a separate sign with raised characters and Braille mounted on the wall adjacent to the latch side of the door.)

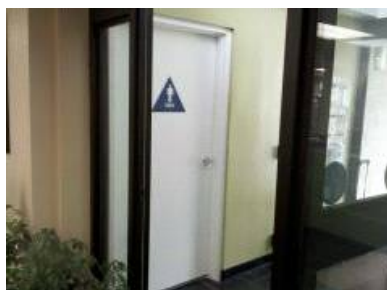
Keynote 103

16.15A - Providing Room/Space ID Sign - A sign designating the permanent room or space has not been provided.

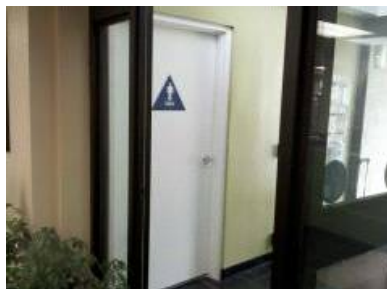
Keynote 104

16.18A - ISA - Accessible toilet room is not identified by an ISA.

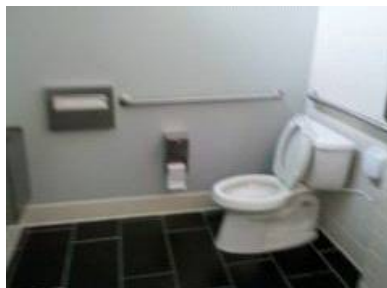
Keynote 105

Existing Condition: 49" clear.

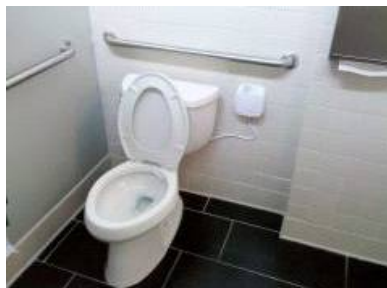
Keynote 106

Existing Condition: 16" to wall.

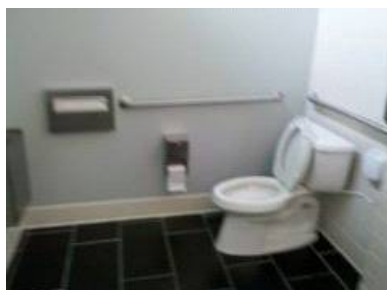
Keynote 109

Existing Condition: 35 1/4" AFF.

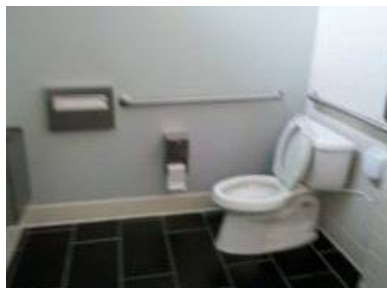
Keynote 110

Existing Condition: 1 3/4" clear.

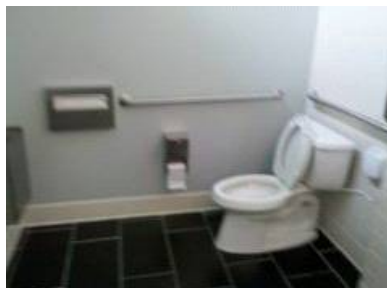
Keynote 111

Existing Condition: 51 1/2".

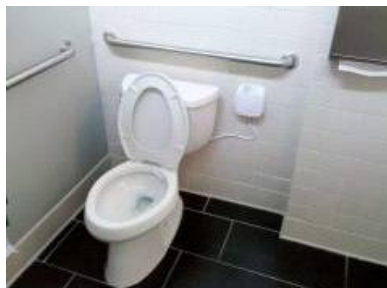
Keynote 112

Existing Condition: Not on wide side.

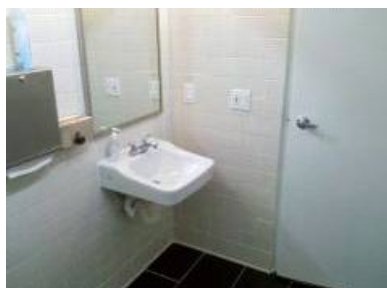
Keynote 117

16.82A - Mirror Height - Max. 40" AFF Standard - Mirror above accessible lavatory or countertop is mounted so the bottom edge of the reflective surface is not 40" max.. AFF. (ADA Standards require at least one mirror to be accessible; CBC Standards prior to August 1, 2009 required all mirrors to be accessible. Effective August 1, 2009, amended CBC Standards require all mirrors above accessible lavatories or countertops to be accessible.)

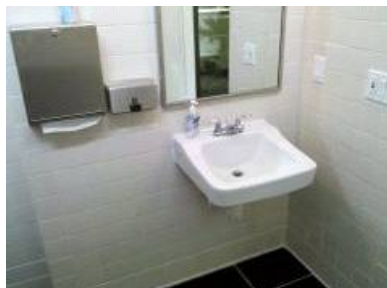
Keynote 118

16.84C - Soap Dispenser - Operating Height - Mounting height of soap dispenser's highest operable part exceeds 40" AFF. (Where provided, ADA Standards require at least one soap dispenser to be accessible with the highest operable part placed within at least one of the reach ranges specified in 4.2.5 and 4.2.6; where provided, CBC Standards require at least one soap dispenser to be accessible with the highest operable part no higher than 40" AFF.)

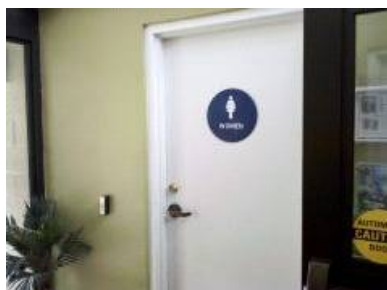
Keynote 123

16.11A - Door Operating Effort - The force required to operate door exceeds 5 lbs. (Fire doors may have up to 15 lbs to achieve positive latching).

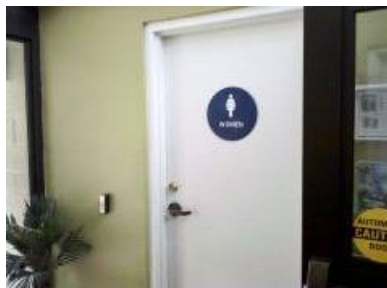
Keynote 124

16.13B - Women's RR Geometric Symbol Signage - Circle - Doorway leading to a women's toilet room is not identified by a circle, 1/4" thick and 12" in diameter. OR Circle is provided, however it is accompanied by words in raised characters and Braille. (ADA and CBC Standards require a separate sign with raised characters and Braille mounted on the wall adjacent to the latch side of the door.)

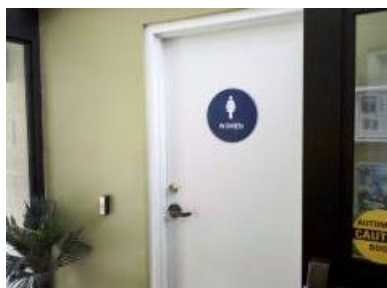
Keynote 125

16.14A - Mounting Height - Geometric Symbol Signage - The geometric symbol is not centered on the door leaf. OR The symbol is not mounted at a height of 60" AFF.

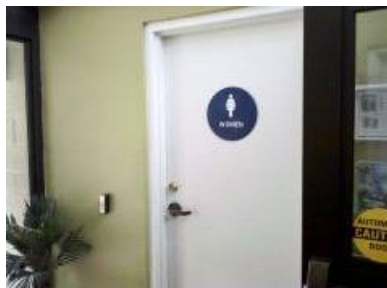
Keynote 126

16.15A - Providing Room/Space ID Sign - A sign designating the permanent room or space has not been provided.

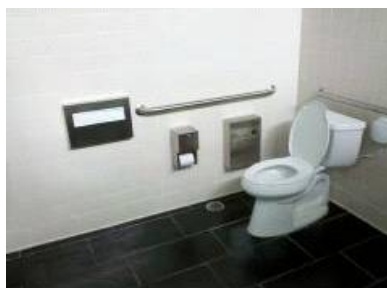
Keynote 133

16.59 - Side Grab Bar - At WC providing front transfer, the side grab bar location is not compliant. (CBC Standards require the side grab bar to extend at least 54" min.. beyond the back wall while the other end is 12" max.. from the back wall. CBC also requires the grab bar's front end to be positioned 24" min.. in front of the WC.)

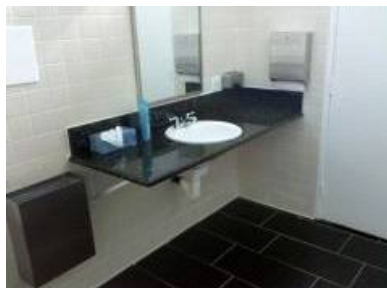
Keynote 134

16.71 - Lavatory - Rim Height - Height of lavatory rim or counter surface exceeds 34" AFF.

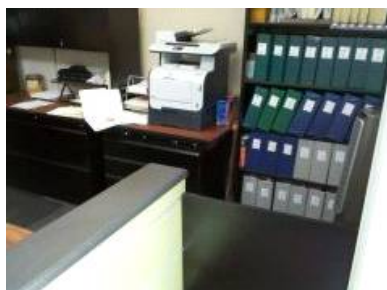
Keynote 161

12A.03 - U-Turn - Where the accessible route of travel makes a U-turn around an obstacle which is less than 48" wide, the pathway width does not increase to at least 42" on the approaches or 48" in the turn.

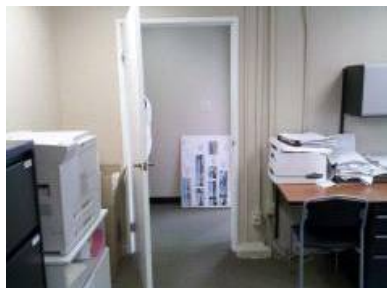
Keynote 173

11.06A - Door Maneuvering Space - Door that is not automatic or power-assisted does not have compliant maneuvering space relative to the direction of approach as shown in CBC Fig. 11B-26. (Approach // Side // Width // Depth) (Front // Pull // D + 24" * // 60") (Front // Push // D + 0" ** // 48") (Latch // Pull // D + 24" // 60") (Latch // Push // D + 24" // 44" ***) (Hinge // Pull // D + 36" // 60") (Hinge // Push // 54" **** // 44" *****) (* D + 18" at interior doors.) (** D + 12" if door has both a latch and a closer.) (*** 48" if door has closer.) (**** Measured from latch toward hinge.) (***** 48" if door has both a latch and a closer.)

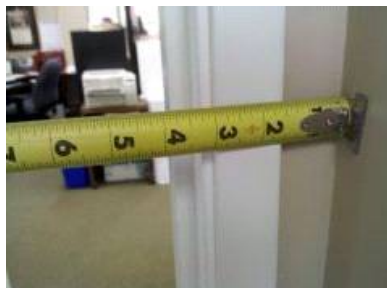
Keynote 190

11.06A - Door Maneuvering Space - Door that is not automatic or power-assisted does not have compliant maneuvering space relative to the direction of approach as shown in CBC Fig. 11B-26. (Approach // Side // Width // Depth) (Front // Pull // D + 24" * // 60") (Front // Push // D + 0" ** // 48") (Latch // Pull // D + 24" // 60") (Latch // Push // D + 24" // 44" ***) (Hinge // Pull // D + 36" // 60") (Hinge // Push // 54" **** // 44" *****) (* D + 18" at interior doors.) (** D + 12" if door has both a latch and a closer.) (***) 48" if door has closer.) (**** Measured from latch toward hinge.) (***** 48" if door has both a latch and a closer.)

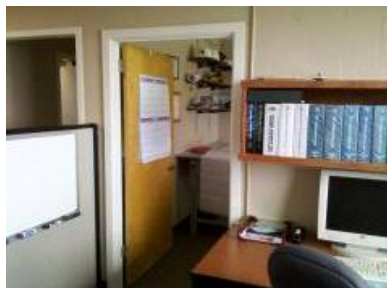
Keynote 216

11.17A - Recommendation: Providing Room/Space ID Sign - A sign designating the permanent room or space has not been provided.

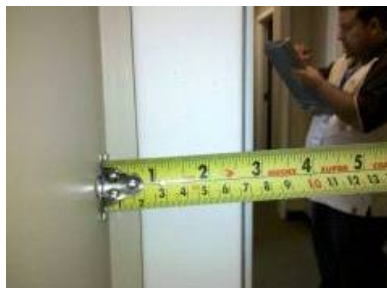
Keynote 224

11.06A - Door Maneuvering Space - Door that is not automatic or power-assisted does not have compliant maneuvering space relative to the direction of approach as shown in CBC Fig. 11B-26. (Approach // Side // Width // Depth) (Front // Pull // D + 24" * // 60") (Front // Push // D + 0" ** // 48") (Latch // Pull // D + 24" // 60") (Latch // Push // D + 24" // 44" ***) (Hinge // Pull // D + 36" // 60") (Hinge // Push // 54" **** // 44" *****) (* D + 18" at interior doors.) (** D + 12" if door has both a latch and a closer.) (***) 48" if door has closer.) (**** Measured from latch toward hinge.) (***** 48" if door has both a latch and a closer.)

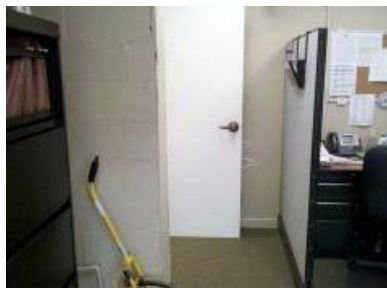
Keynote 227

14.21B - 36" Width Standard - The accessible route of travel is not at least 36" wide where the occupancy load is < 10. (For a depth of 24" max., clear opening width may be reduced to 32" min.) (Doorways are compliant when the door, open 90 degrees, affords a clear opening width of at least 32".)

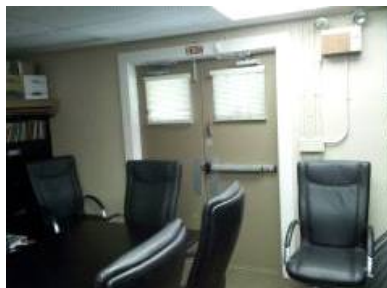
Keynote 242

14.21A - 44" Width Standard - The accessible route of travel is not at least 44" wide where the occupancy load is ? 10. (For a depth of 24" max..., clear opening width may be reduced to 32" min...) (Doorways are compliant when the door, open 90 degrees, affords a clear opening width of at least 32".)

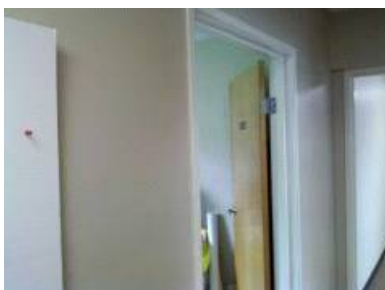
Keynote 311

11.23A - Mounting Location (Visual/Tactile Signs) - Sign is not mounted on the wall adjacent to the latch side of the door. OR At double leaf doors, the sign is not placed on the nearest adjacent wall.

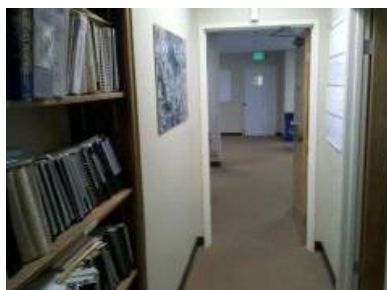
Keynote 317

11.14 - Closers - Door closer is not adjusted so that from an open position of 70 degrees, the door will take at least 3 seconds to move to a point 3" from the latch (measured to the leading edge of the door).

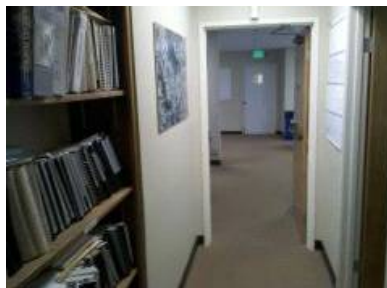
Keynote 318

11.15A - Kick Plate - Bottom 10" of door does not have a smooth, uninterrupted surface on the push side to allow the door to be opened by a wheelchair footrest without creating a trap or hazardous condition. (This requirement does not apply to automatic and sliding doors.)

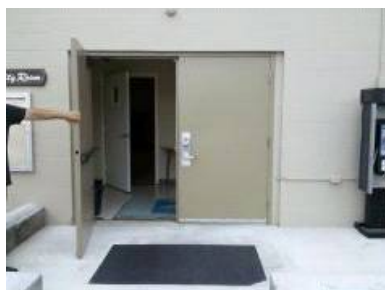
Keynote 340

11.14 - Closers - Door closer is not adjusted so that from an open position of 70 degrees, the door will take at least 3 seconds to move to a point 3" from the latch (measured to the leading edge of the door).

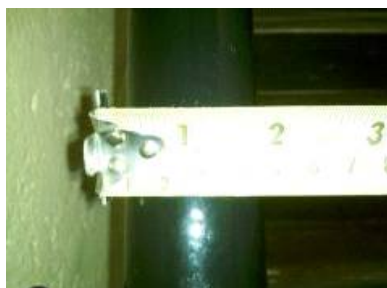
Keynote 350

08.10A - Profile of Handrails - The diameter of the handrail is not between 1-1/4" and 1-1/2" in cross-sectional nominal dimension. OR The shape does not provide an equivalent gripping surface (equivalent gripping surfaces are 4" to 6-1/4" in perimeter, and 2-1/4" max. in any direction). (Note: Standard pipe sizes designated by the industry as 1-1/4" to 1-1/2" are acceptable).

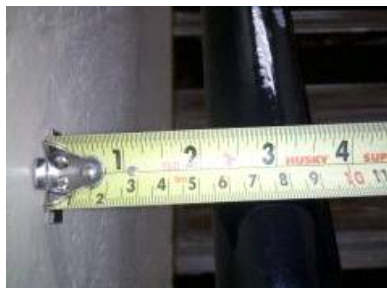
Keynote 351

08.10B - Clearance - The clear space between handrails and walls is not 1-1/2" absolute. (ADA/CBC Standards apply an absolute dimension of 1-1/2", which provides knuckle clearance while generally disallowing entrapment of the forearm or elbow.)

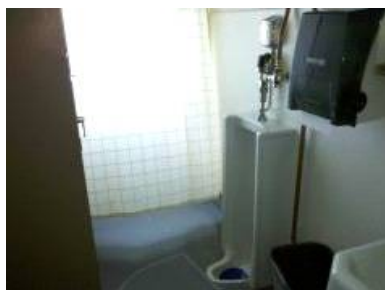
Keynote 443

16.84A - Paper Towel Dispenser - Operating Height - Mounting height of paper towel dispenser's highest operable part exceeds 40" AFF. (Where provided, ADA Standards require at least one paper towel dispenser to be accessible with the highest operable part placed within at least one of the reach ranges specified in 4.2.5 and 4.2.6; where provided, CBC Standards require at least one paper towel dispenser to be accessible with the highest operable part no higher than 40" AFF.)

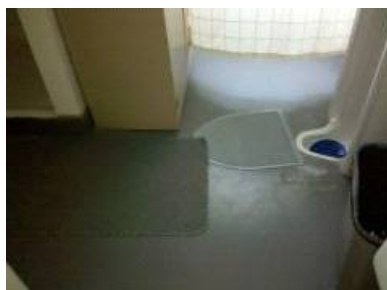
Keynote 447

14.23B - Floor Surface - Accessible route surfaces are not stable, firm and slip-resistant.

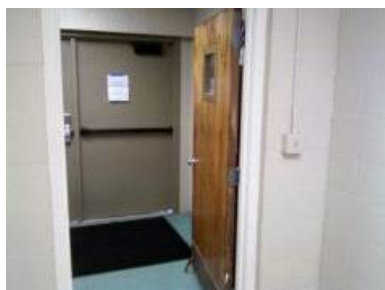
Keynote 465

11.14 - Closers - Door closer is not adjusted so that from an open position of 70 degrees, the door will take at least 3 seconds to move to a point 3" from the latch (measured to the leading edge of the door).

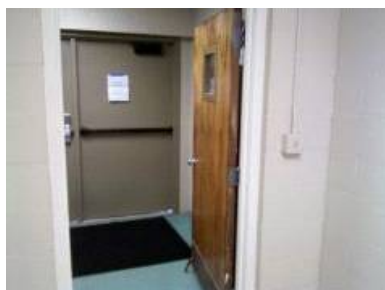
Keynote 479

11.14 - Closers - Door closer is not adjusted so that from an open position of 70 degrees, the door will take at least 3 seconds to move to a point 3" from the latch (measured to the leading edge of the door).

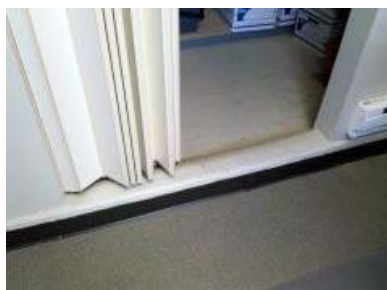
Keynote 676

14.02 - Accessible Route - Accessible routes of travel do not connect the room or space to an accessible entrance within the building or facility.

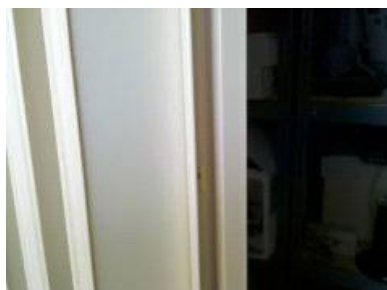
Keynote 677

11.11 - Single-Action Hardware - Handles, locks, and latches or other operative devices are not operable with one hand and without tight grasping, pinching, or twisting of the wrist. (U-shaped handles, levers, and push/pull type mechanisms are acceptable designs.)

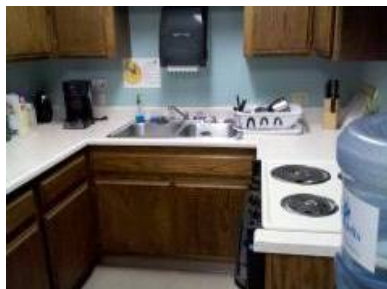
Keynote 679

14.36B - Kitchen Counter/Sink Height - Where provided in public or common use areas, countertops and sinks are not mounted at 34" AFF. max..(Common use areas are those interior and exterior rooms, spaces, or elements that are made available for the use of a restricted group of people (for example, the occupants of an office building, or the guests of such occupants).

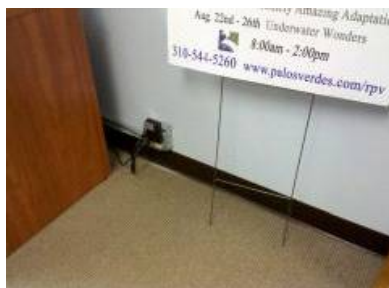
Keynote 718

14.32A - Reach Range - Controls - Controls, dispensers, and similar devices are not between 9" and 54" AFF when the clear floor space allows a parallel approach. OR They are not between 15" and 48" AFF when the clear floor space allows only a forward approach.

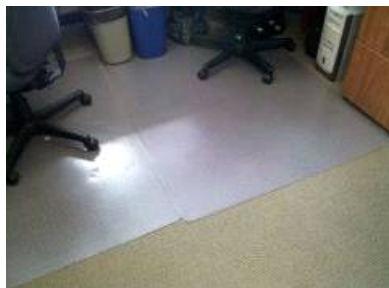
Keynote 719

14.23B - Floor Surface - Accessible route surfaces are not stable, firm and slip-resistant.
